# Stepper Motor Failure

## The stepper motor problem

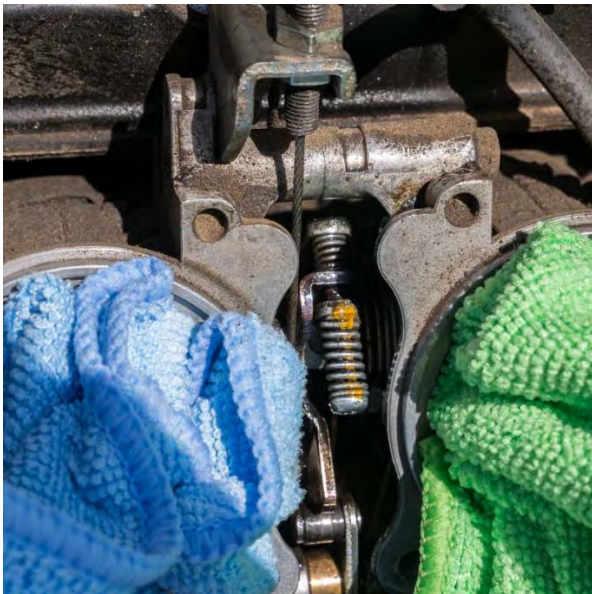
*Top of the stepper, throttle linkages and inlets. This whole area gets really dirty, this was a picture from Mexico about 3,000 miles after the last clean. It's the dirt and grime that causes poor idling and stalling.*

Since the beginning of this trip I have religiously kept the stepper motor clean during regular servicing. It's also essential to clean and lubricate the roller and throttle linkages that the stepper motor engages with. I'm convinced that problems people report are related to dirty roller and linkages and not inherently an issue with the stepper motor which continues to function. Actual failure of the stepper motor is quite rare.

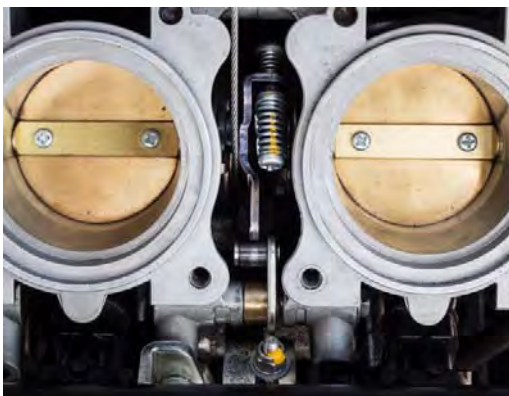
*After a clean up. Usually enough to keep things nicely ticking over.*

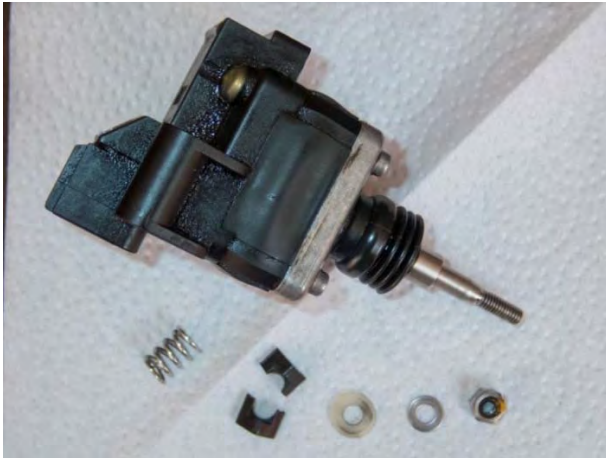
We crossed the border back into Colombia (the crossing was just a reversal of the crossing in the opposite direction [documented in this blog entry](#)), and booked ourselves into the Hotel Avanty in Ipiales. With their secure underground parking this was an ideal place to work on the bike. On disassembly it was immediately obvious what the issue was. A small plastic part that pushes against the throttle linkage had broken. I've never seen this failure mechanism reported elsewhere. It's clear in the picture below what the issue was. Hint, the two small black parts at the bottom of the photo should be in one piece.

*A quick clean isn't going to sort this out.*

My initial thought was to try and fix the piece that had broken. Thorough cleaning and subsequent gluing of the part with superglue was not a success. It lasted all of three seconds before falling apart again. In hindsight it was a stupid idea. Secondly, I tried shaping and using washers but these were easily bent and idle was not good. I did consider trying to get a new part made from aluminium in a small workshop but couldn't find anyone interested in taking the job on.

The answer was to completely bypass the stepper motor. This entailed removal of the offending device and replacing with a mechanical means of managing tickover. It's necessary to cable tie (zip tie) the stepper motor out of the way and keep it connected to the ECU. Not doing so would result in the ECU throwing lots of error codes at it looked for the stepper. The check engine light on the console would also be constantly illuminated.

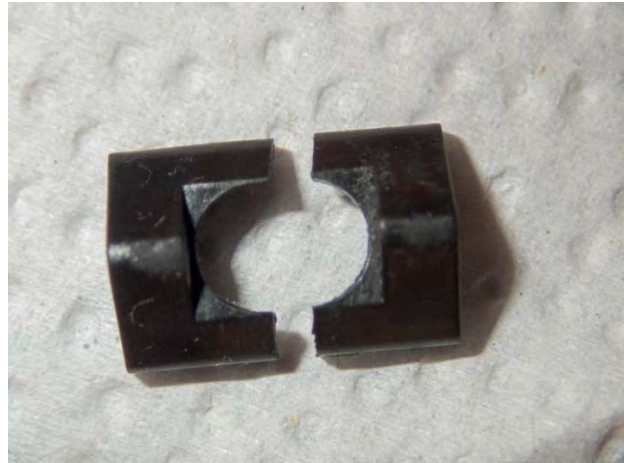
*Not seen anyone report this kind of failure before.*

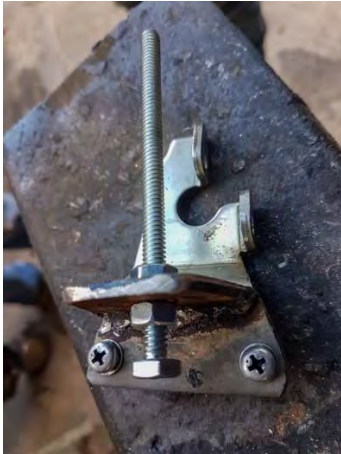
*A few hours trying to find a workshop that understood what I needed and were willing to help and I was set. Took about 3 hours to make the manual adjuster and so far no issues at all. Not at all pretty though.*

Scouring the "workshop" part of town we eventually found a place that not only seemed to understand what I needed but could also do the job that afternoon. They didn't have angle iron so instead fabricated a piece by welding two pieces of metal together. What they produced wasn't pretty as you can see. Total cost was 40,000 Colombian pesos, About £10 GBP.

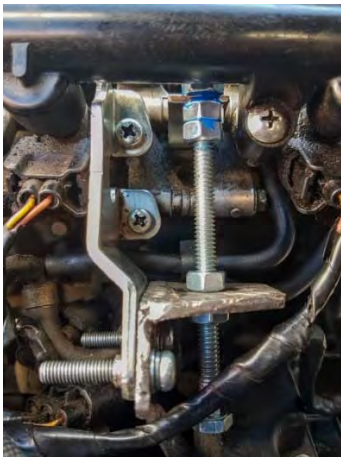
*Manual adjuster fitted in place of the stepper. The two longer screws towards the left, front and rear, are re-used from the stepper motor. Never know if I might need to refit one.*

I fitted the new adjuster, made a best guess for adjustment, and replaced the airbox and fuel tank. One press of the starter and Tigger sprung into life and idled at a rather brisk 1,400 rpm. A few tweaks with a pair of open ended spanners and the idle was just where it needs to be. Note that it's possible to adjust the idle at the side of the road without removing any components from the bike. Nice.

Since fitting the manual adjuster I've had no issues with Tigger's idle. Regardless of temperature or altitude, idle has held steady at 1,100 rpm. I couldn't be happier with the outcome as it effectively removes one electronic component from the bike. Highly recommended as a remedial solution or a pre-emptive strike before the dreaded stepper motor ruins your ride..

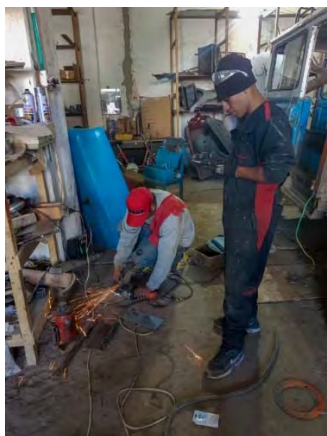
*A few minor adjustments here and there.*

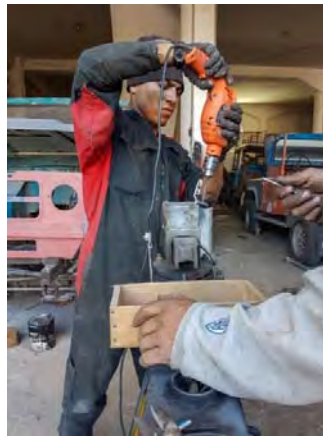
*Not sure why they didn't use their pillar drill?????*
